Second Report on
The Jason Strevell House
Located in Pontiac, Illinois
September 18, 2012
By Tom Vance

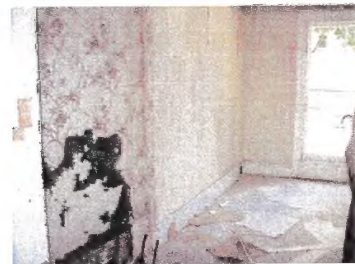
The paneling had been removed in the east parlor revealing several layers of wall paper and underneath that, the original dark green paint. The arched doorway and wall dividing the room appears to be original to the construction but a closer examination needs to be made. The configuration of the chimney in these rooms is still unknown. There should be some evidence of the chimney on the wall when wall paper is removed.

Recommendation – carefully remove wall paper exposing the dark green paint. SAVE large samples of the wall paper and plaster. Remove the textured plaster from the ceiling along with wall paper. It is possible that the ceiling was also painted dark green. See if any large areas of the dark green paint can be preserved.

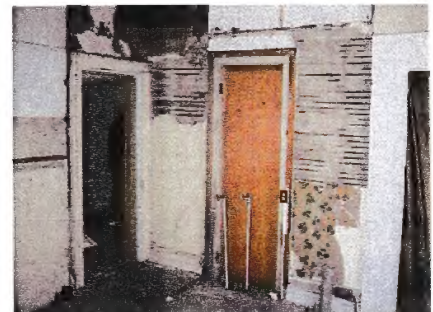
The configuration of the original house has yet to be determined. Removing the later bathroom in that area will help determine such things as the location of the original stairs to the second floor. An interesting door was uncovered in the west room of the original house. This door opened east toward the main room and is now blocked with plywood. It was added later, probably when the new addition was built. It may have led to a pantry, but needs to be further investigated.
